**HISTORIC PRESERVATION  
BOARD**

**Case No. H20-06  
133 N. Court St.**

**Subject:** Certificate of Appropriateness – Complete building demolition

Re: 133 North Court Street

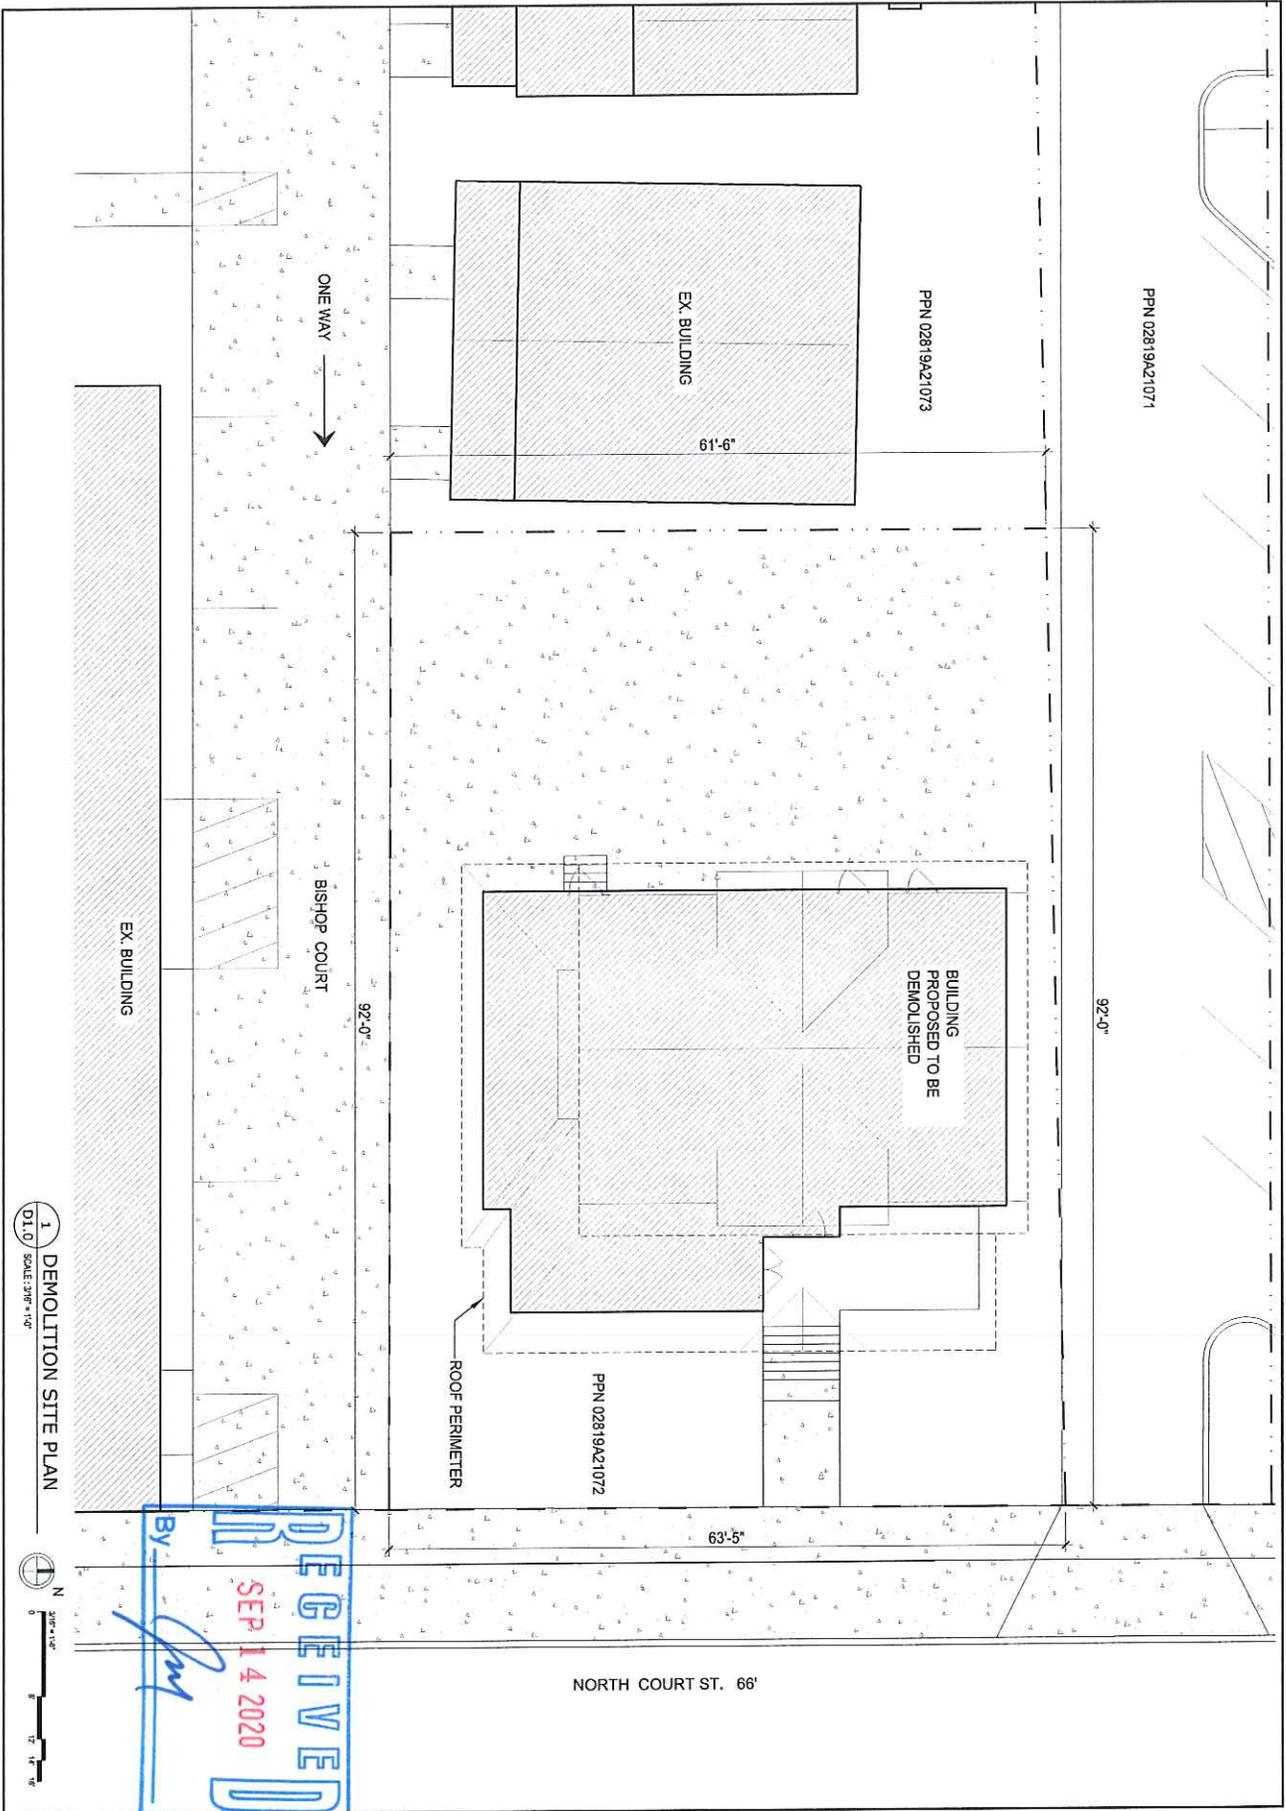
1  
D1.0  
SCALE: 3/8" = 1'-0"  
DEMOLITION SITE PLAN

DEMOLITION SITE PLAN  
PROJECT #: 21420 DATE: SEPTEMBER 4, 2020  
FORMER FUNERAL HOME  
133 NORTH COURT  
MEDINA, OHIO 44256
