**HISTORIC PRESERVATION
BOARD**

**Case No. H19-08
117 E Liberty**

Case No: H19-08 (continued from June 13, 2019)
Address: 117 E. Liberty St.
Applicant: Illes Architects representing The Odd Fellows
Subject: Certificate of Appropriateness – Storefront renovation
Zoning: C-2, Central Business
Submitted by: Jonathan Mendel, Community Development Director

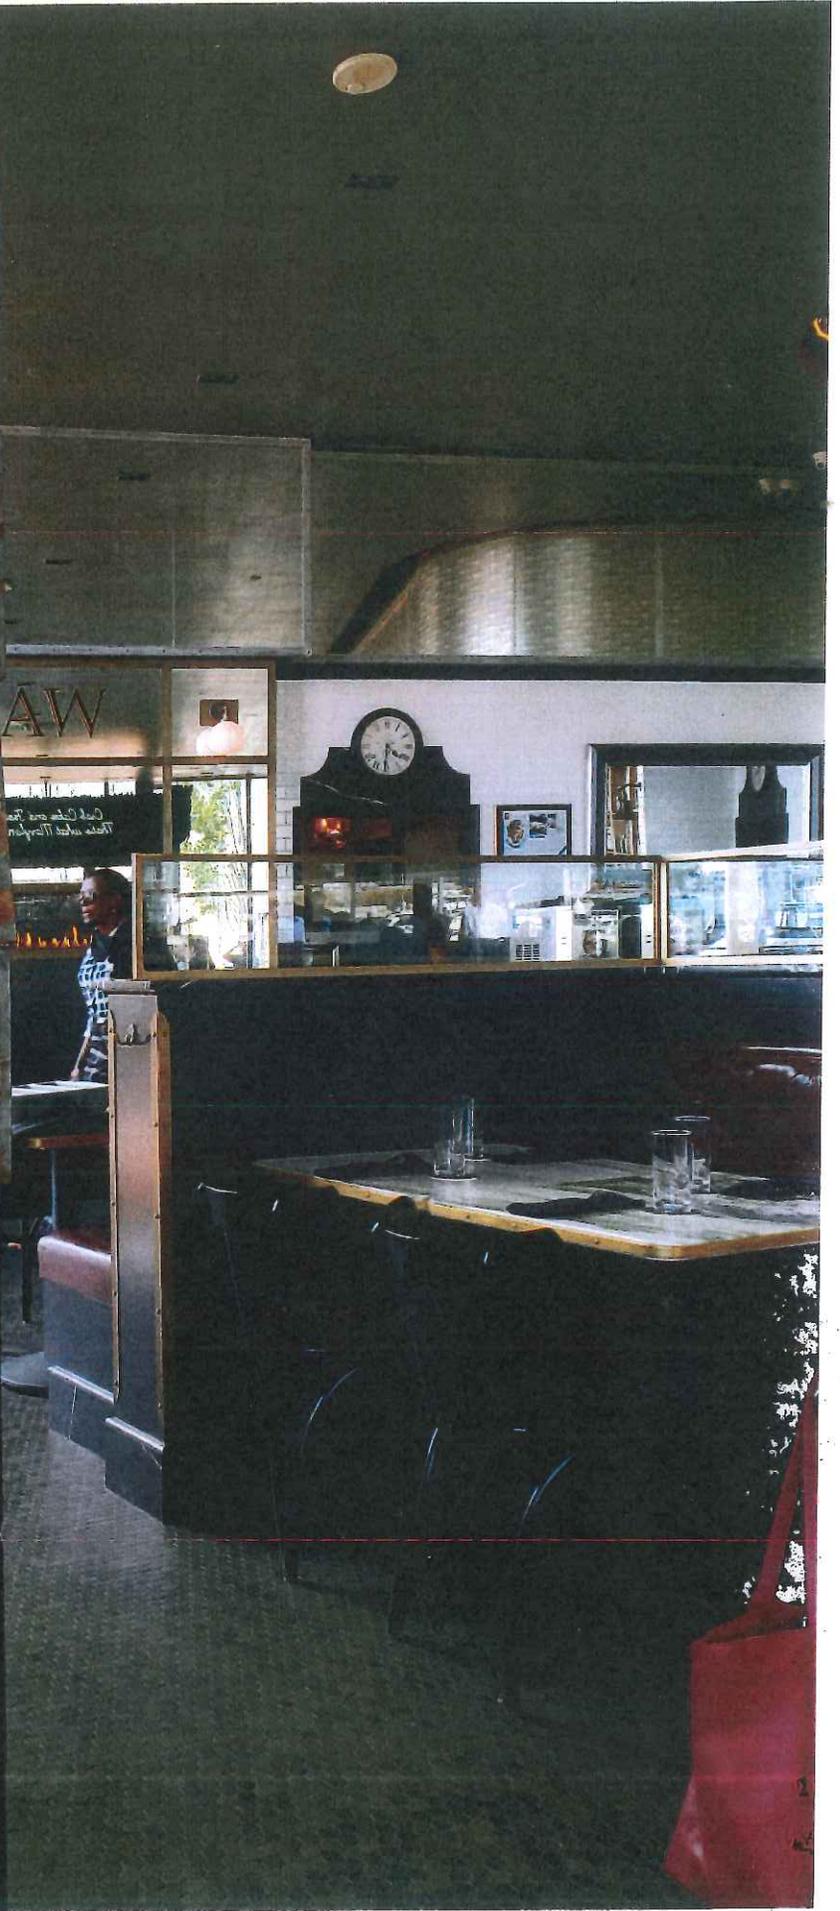
ELEVATION REVISIONS

The applicant's revised storefront renovation plan has removed the fluted pilasters on the storefront piers, changed to black ceramic glazed tile for the new storefront bulkheads and changed the finished detailing of the storefront piers to incorporate simplified paneled sections.

Scale 1/4"=1'-0"

1. Revised building elevation renovation plan received June 27, 2019

Staff recommends the Historic Preservation Board **approve** a storefront renovation plan (received June 27, 2019) for 117 E. Liberty St with the following condition:

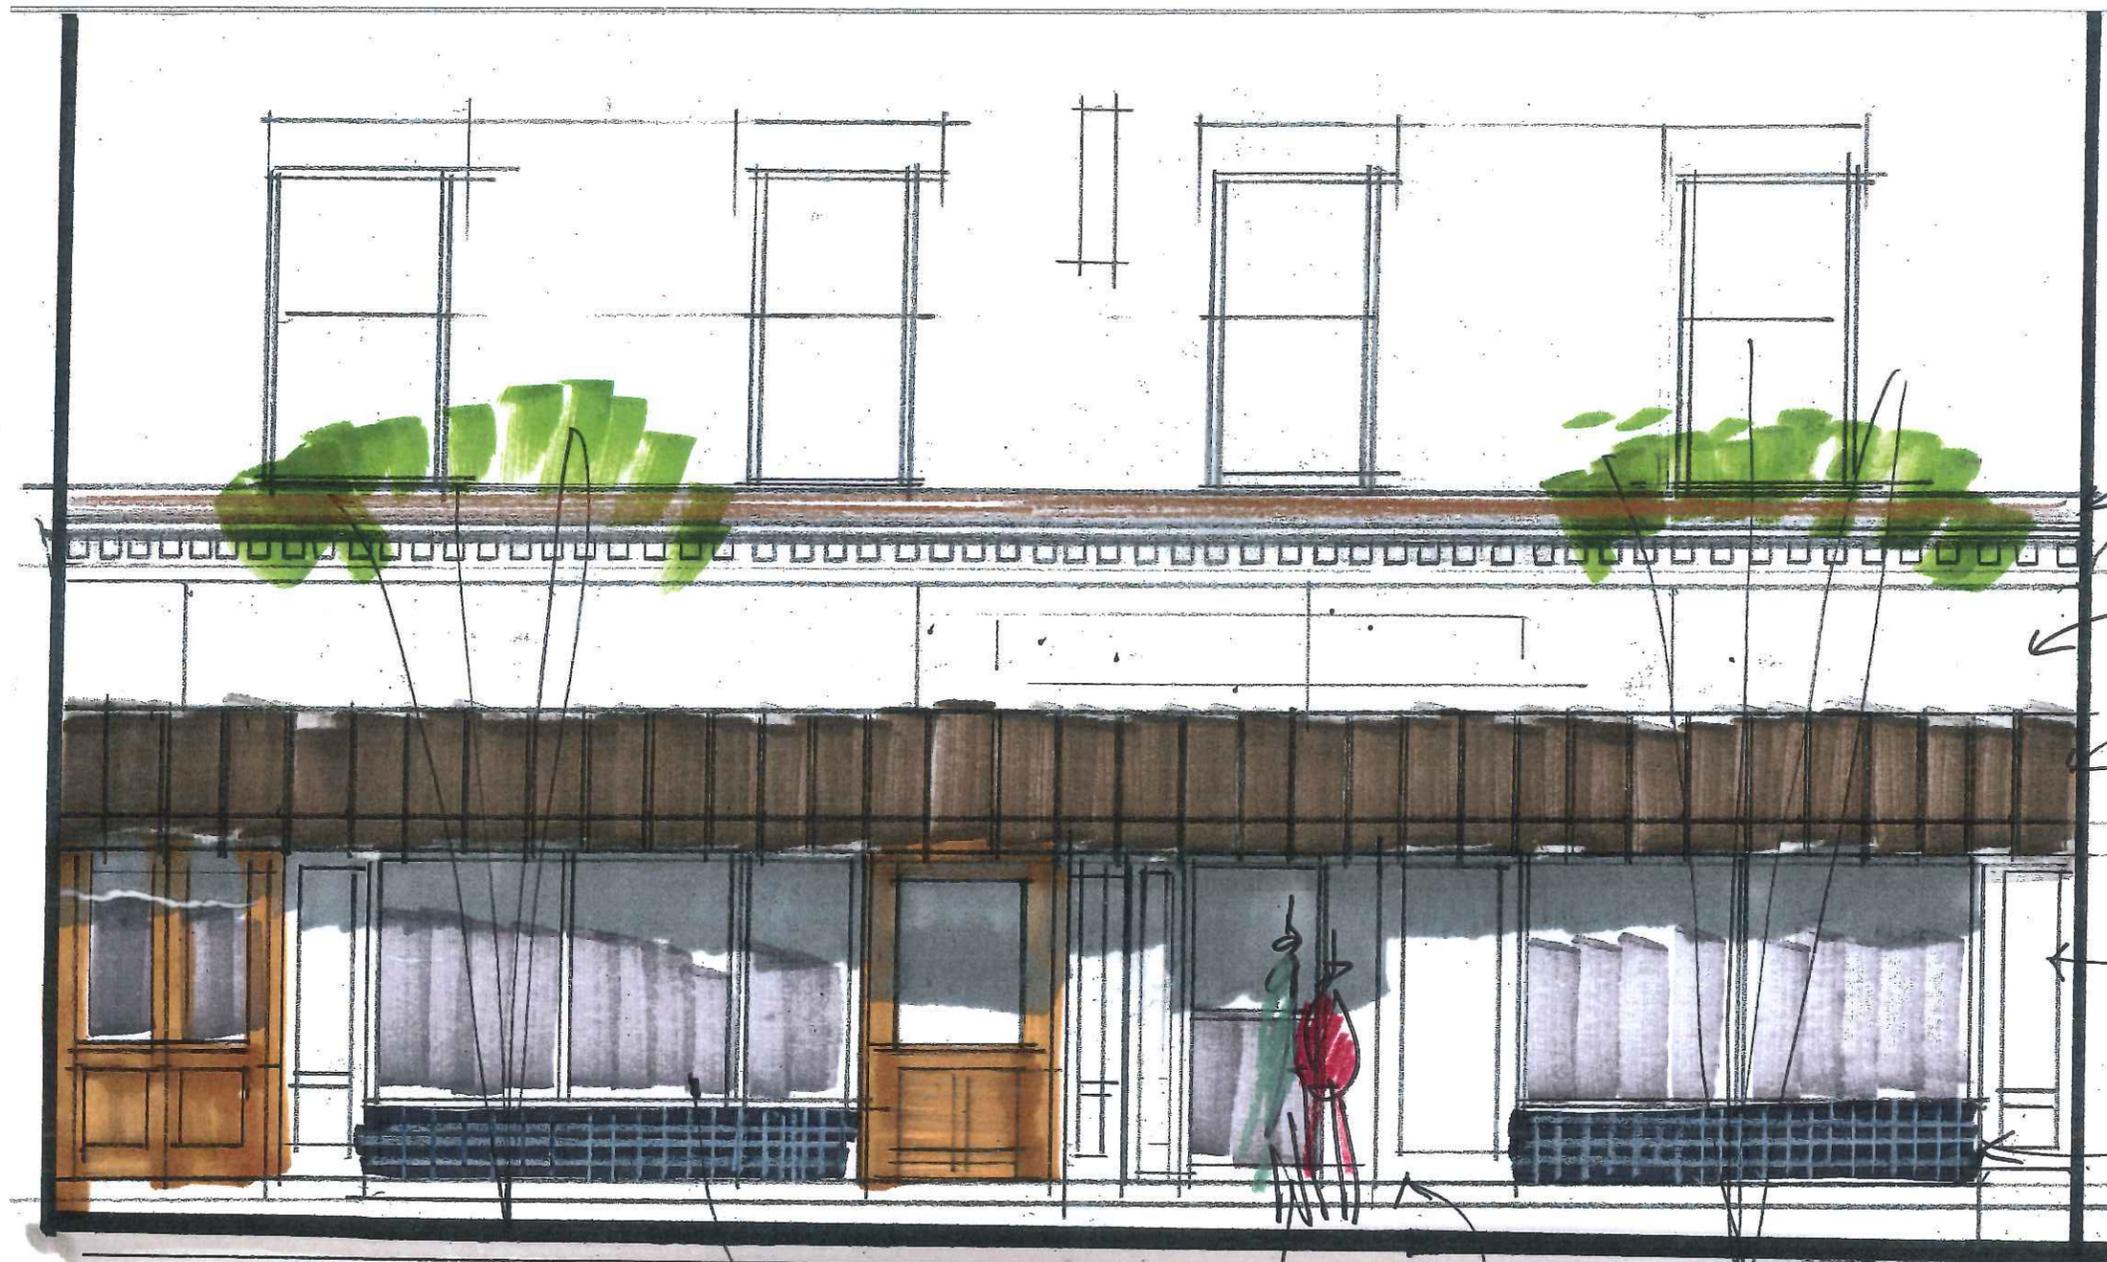
SK-2

copper

white
dark
bronze

white trim
panels

black
glass tile
w/white
grout

white starfront alum

matblack tile 2019
octagon floor tile

The revised renovation plan dispensed with the fluted pilasters on the storefront piers and now proposes simplified panel detailing for the piers similar to the paneled piers shown in the available historical photos.
